**Coal Combustion Residue Impoundment  
Round 9 - Dam Assessment Report**

*Plant Kraft*  
*CCR Impoundment Ash Dikes*  
*Georgia Power*  
**Port Wentworth, Georgia**

Dewberry & Davis, LLC  
Fairfax, Virginia

Under Contract Number: EP-09W001727  
**December 2011**

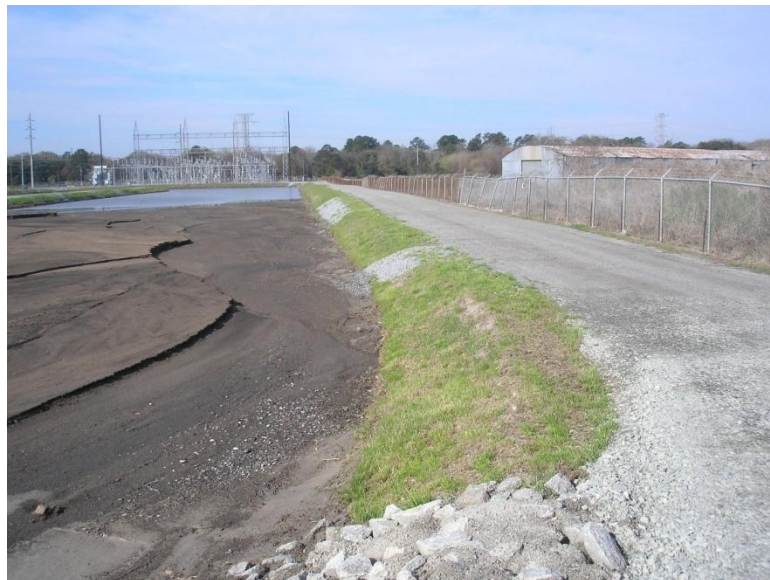
Figure 5.2.1-1: Embankment Crest on North Side of CCR Impoundment

The crest of the CCR impoundment embankment had no signs of depressions, tension cracks, or other indications of failure. Previous inspection reports reviewed by Dewberry did not indicate issues concerning the crest. Figure 5.2.1 – 1 shows the condition of the embankment crest.

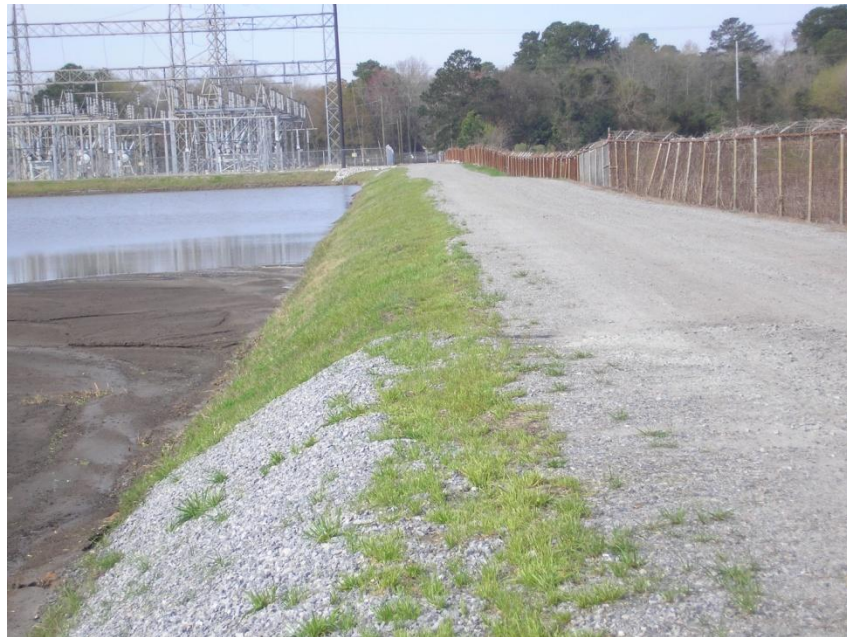
Figure 5.2.2-1: Inside Slope of Embankment on North Side of Impoundment

The inside slope of the embankment is covered with grass vegetation. There were no observed scarps, sloughs, bulging, cracks, depression, or other indications of slope instability or signs of erosion. Areas of the inside slope impacted by surface runoff across the crest have been armored by the addition of small riprap. Figure 5.2.2-1 shows the general condition of the slope and an area to which riprap protection has been added.

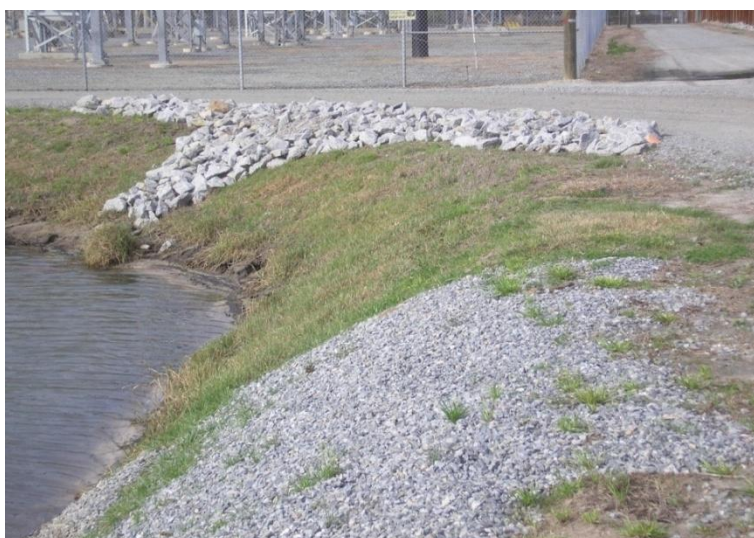
Figure 5.2.4-1: Groin Area in Northwest Corner of Embankment

Erosion or uncontrolled seepage was not observed along embankment groins. Embankment groins on the north side of the CCR impoundment have had riprap added to protect against erosion caused by surface runoff across the embankment crest.

Figures 5.2.4-1 and 5.2.4-2 show the inside slope at the northwest and southeast groins, respectively.

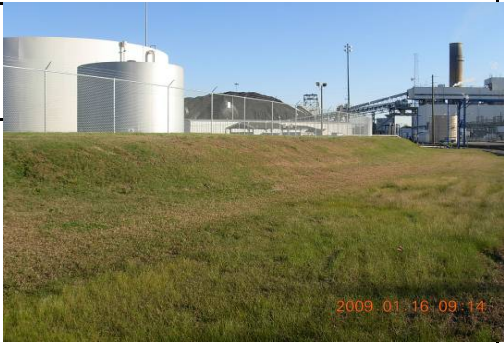
287 2838	South side of oil tank containment (looking northeast) Grass is thin in some spots on outside of containment dike.

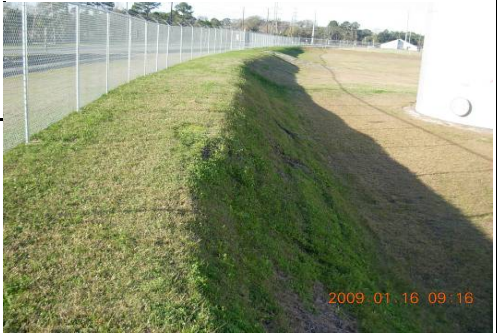
290 2840	This segment of the outside of the containment dike is way too steep. This is contributing to the erosion. The best way to fix this would be to import some soil and flatten the slope. Barring that, the next best thing to do would be to mulch, seed, fertilize the slope, then mow it carefully with weed eaters.

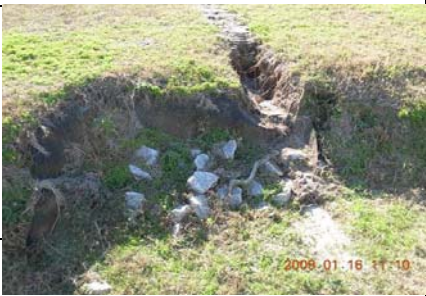
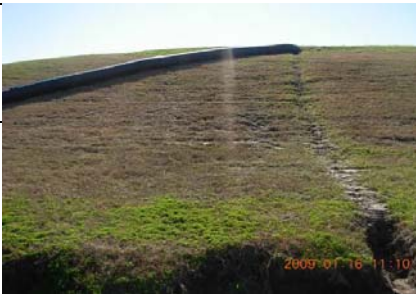
Location No. Photo No.	Description	Photo
301 2862	Eroded area at termination of plastic down drain. The pipe should be put back in place. These oversteep slopes should be laid back to a reasonable slope, then grassed, fertilized and mulched. A splash pad for the down drain outlet should be constructed. This could be made of sand-cement bags or of riprap on a bed of gravel.

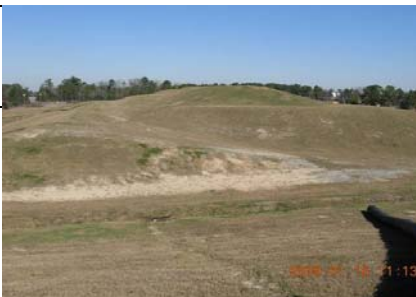
302 2864	View of south cell from north cell.

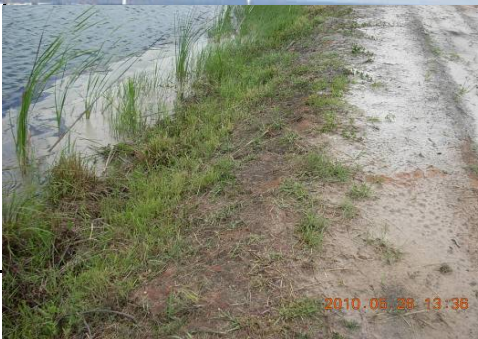
Photo No.	Description	Photo
3904	The mower has scalped the edge of the crest here, while leaving vegetation high near the water. There is a high potential for mowers to do more harm than good. <b>This area will need to be reseeded, fertilized and mulched.</b> Improper mowing does more harm than good.

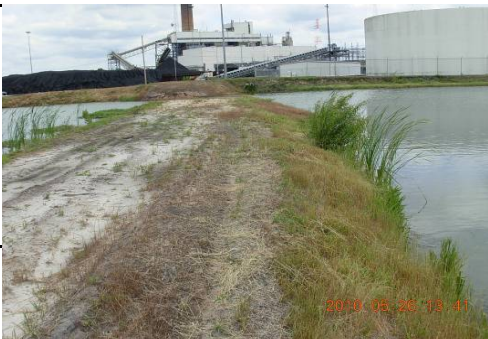
3905	As in the photo above, the mower has scalped the edge of the crest while leaving tall vegetation near the water. <b>The tall vegetation, in this case willows, should be cut down and the stumps poisoned.</b> Woody vegetation will degrade earth structures.

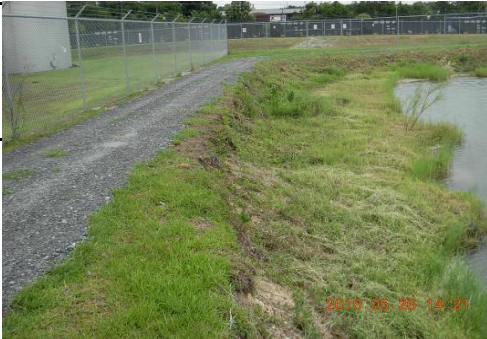
<div> <div>Plant Kraft</div> <div>Ash Pond Dike Inspection Photographs - May 26, 2010</div> <div>(See accompanying report attached)</div> </div>		
Photo No.	Description	Photo
3908	Bare crest of dike. <b>This area would benefit from gravel.</b>	 
3909	The addition of gravel to the crest in this area has worked well. <b>This slope is overly steep and should be flattened with the addition of suitable fill.</b>

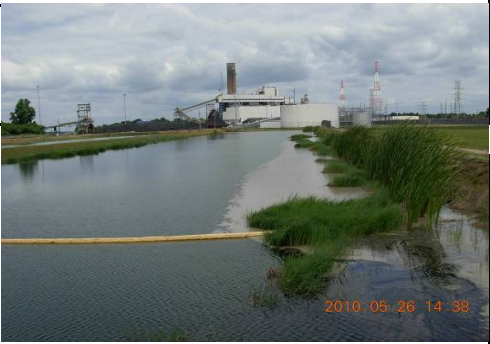
<div> <div>Plant Kraft</div> <div>Ash Pond Dike Inspection Photographs - May 26, 2010</div> <div>(See accompanying report attached)</div> </div>		
Photo No.	Description	Photo
3913	Cattails growing in ash are not a problem from a dam safety standpoint.

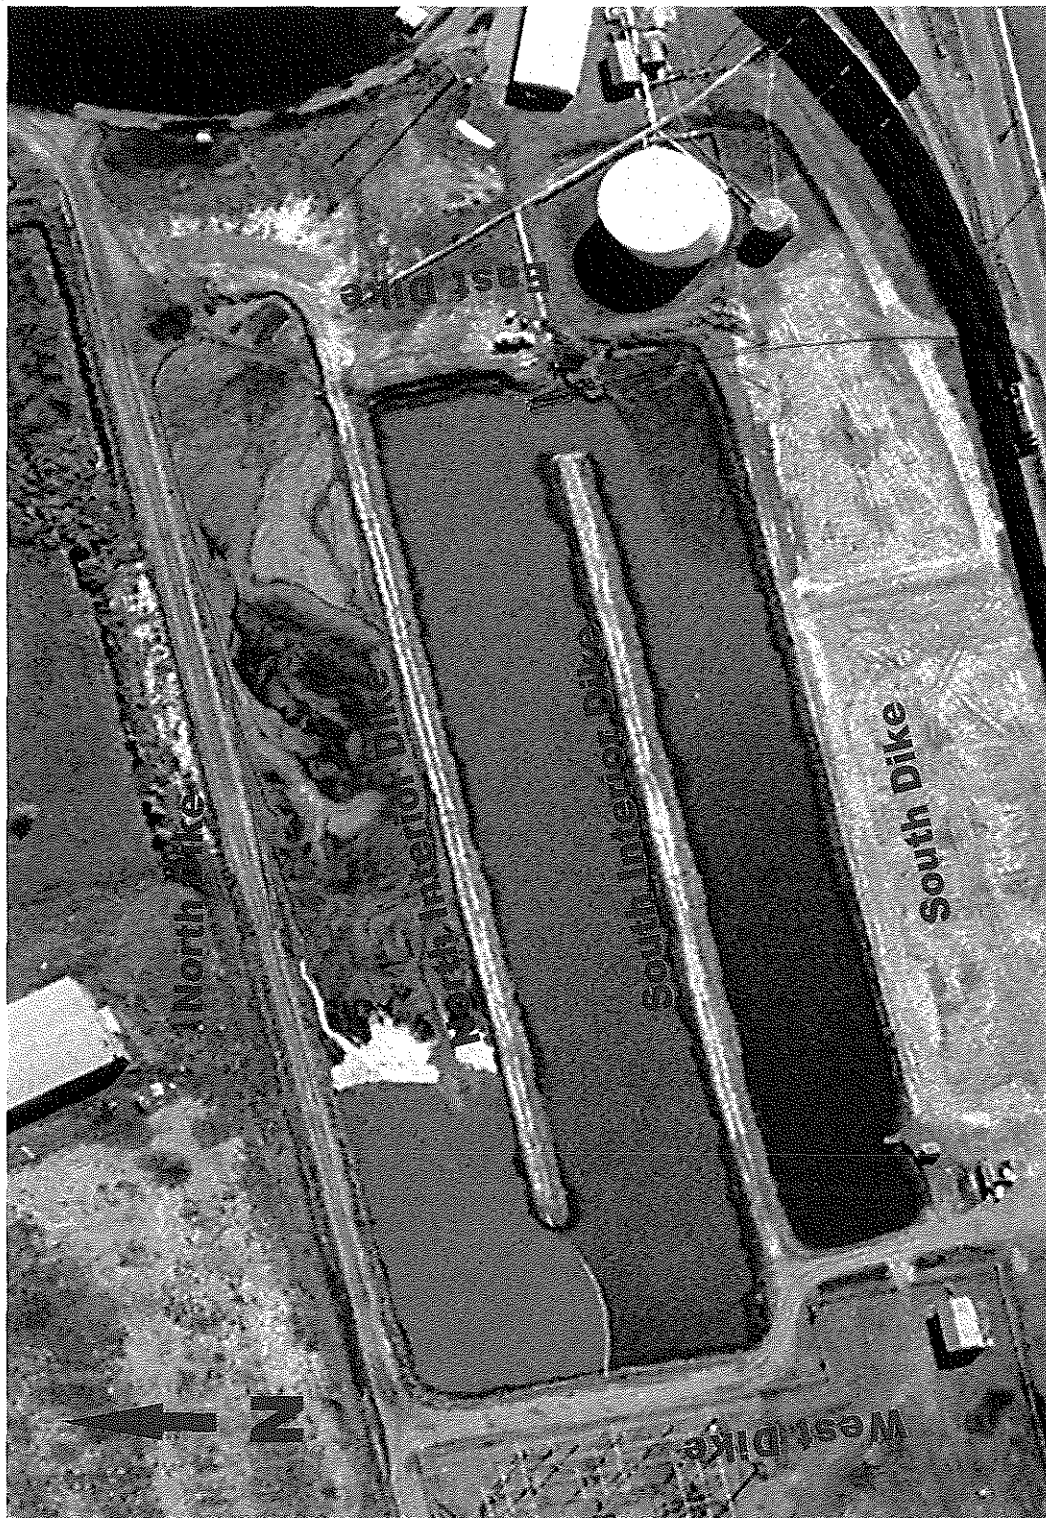
Grass  
thinning  
in  
several  
places

The weekly pond dike inspection log for the week of December 30, 2010 indicated that grass was thin in areas near the southeast corner of the impoundment. The report recommended reseeding and fertilizing the area in the spring.
